MEASURING THE EFFECTIVENESS OF VOLUNTARY PLASTIC INDUSTRY EFFORTS: AMRF'S ANALYSIS OF OPERATION CLEAN SWEEP

C.J. Moore, G.L. Lattin, A.F. Zellers

Algalita Marine Research Foundation, 148 N. Marina Drive, Long Beach, CA 90803, USA

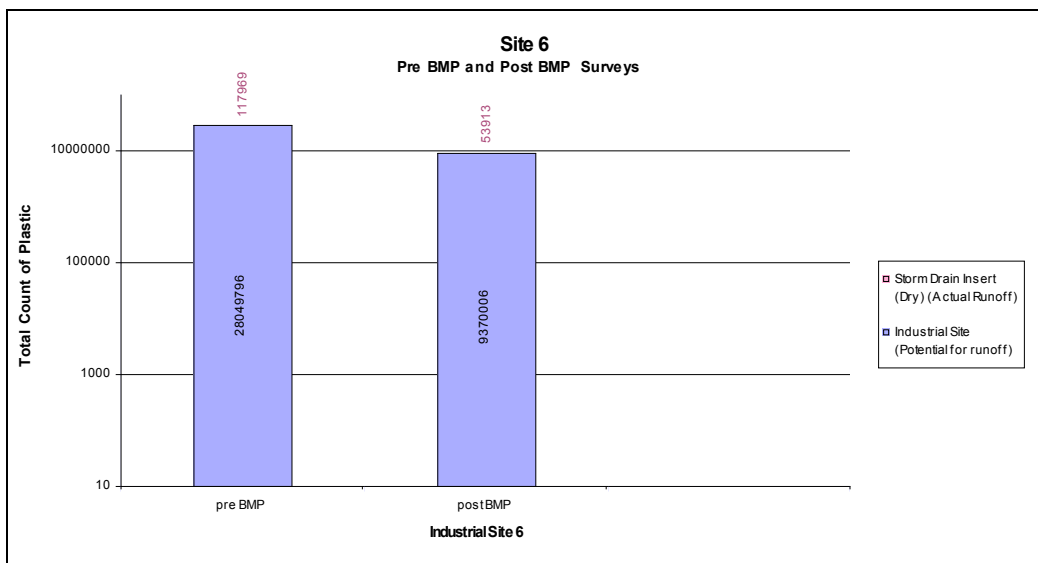
Site 6

The following areas are on the outside grounds of the facility where spilled pellets observed by project personnel have the potential to enter the storm drain system:

1. On the parking lot.
2. By the pellet storage silos on the west and east sides of the main building.
3. By the loading docks.

4. Covering the gravel on the railcar delivery area .
5. On the paved machinery and equipment storage area.
6. Next to the neighboring building on the east side of the facility.

All of these areas continued to contribute lost pellets to the runoff caught by the catch basin insert post BMP.

By comparing the pre BMP and the post BMP surveys, this facility has improved. However, even though the west area of the facility was cleaner, and there were fewer larger spills at the railroad track area, this facility continues to have a high rate of pellet loss on the ground. Many of these pellets are making it to the storm drain system. On several occasions, project personnel have observed the pellet trail from the facility to the catch basin. Going from one hundred thousand pre BMP to fifty thousand pellets post BMP in the catch basin insert samples while representing an improvement, still constitutes excessive pellet loss.

New BMP measures reported by the management include designating an employee to clean up spills inside the factory. Project personnel observed the use of two sock booms that had been placed in the drainage areas on the west side of the facility. Both booms had pellets trapped on the upstream side of the boom, with only a couple of pellets downstream. There was no evidence of vacuuming in the yard.

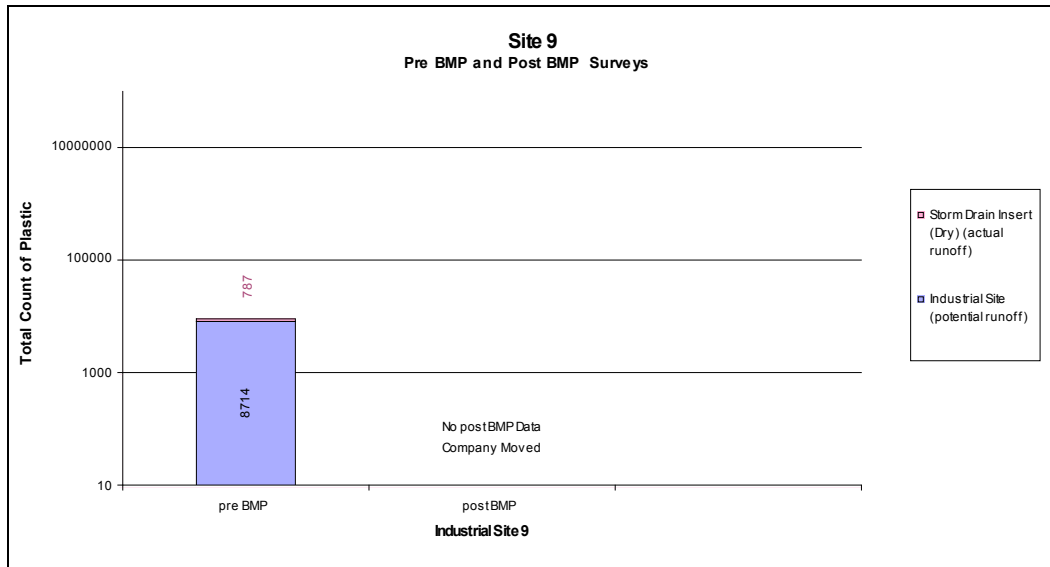
Site 9

Outside locations where plastic pellets and fragments have a potential to enter the storm drain system.

1. On the parking lot.
2. In the driveway by the loading dock.
3. On the platform by the silos.
4. On the gravel at the railcar delivery area.

5. On the paved machinery and equipment storage area.

There were no post BMP Industrial Site samples at this facility. The company moved. They gave permission to the project to install a catch basin insert in a sump by the loading dock. Although this sump does not connect to the storm drain system, during a rain event, it would overflow and floating pellets would come out and possibly flow to a storm drain. This catch basin was sampled during a wet period. It was the only post BMP sample that was taken. There was no indication that the company was moving. When project personnel arrived to do the post BMP sample the facility was under reconstruction. A new layer of gravel had been added at the railroad tracks, covering up many small spills. Project personnel could take pictures, but were not able to obtain permission to take samples.

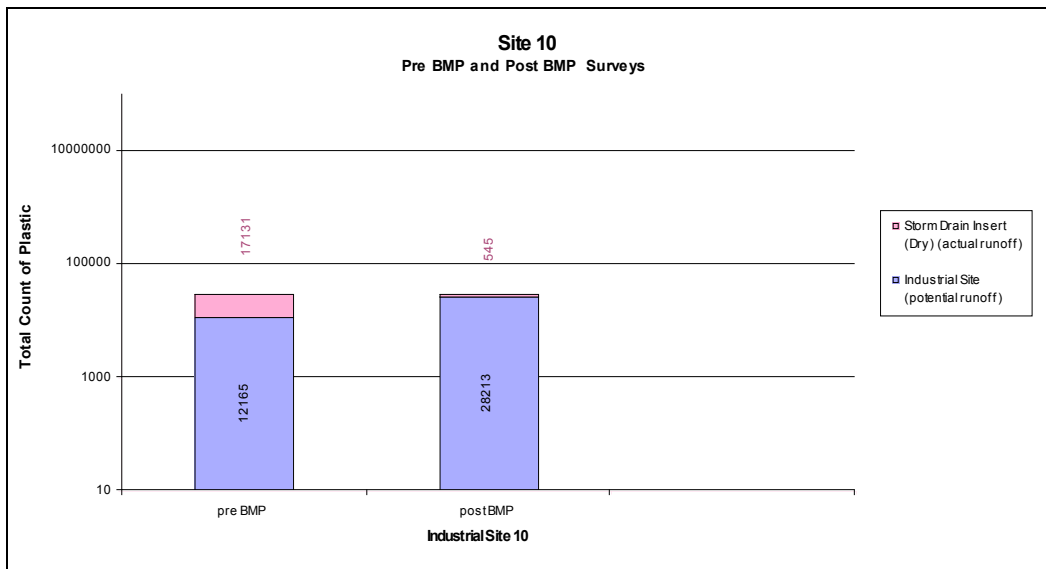
Site 10

Areas where pellets have the potential to enter the catch basins are:

1. The parking lot.
2. The driveway leading to the storage area.
3. The waste bin area.
4. The rear storage area.

By comparing the pre BMP and the post BMP surveys, this facility has remained almost the same, continuing to be a clean facility.

New BMP measures reported by the management included; 1) they change the storm drain insert every 90 days, 2) a vacuum was placed outside as recommended, 3) the Gaylords were covered as recommended, and 4) the dumpster was covered as recommended. Project personnel observed the continued use of the vacuum sweeper, as well as hand sweeping. The storage yard and driveway are both clean, except for very recent small spills.

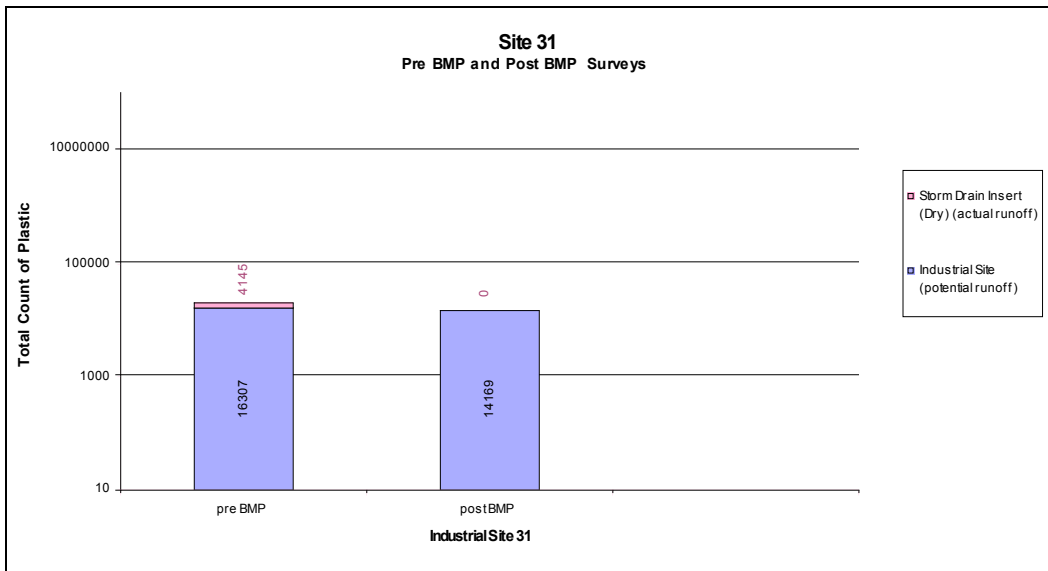
Site 31

All outside areas of the facility that plastic could enter the storm drain system.

1. The parking lot.
2. The loading dock areas.
3. The two rail car siding areas.
4. Pellets and dust were also found on the edge of the creek.

By comparing the pre BMP and the post BMP surveys, this facility has slightly improved, but is overall pretty much the same. Some pellets and dust are on the ground in the washout area. The asphalt surfaces in some areas are worn down, which traps the pellets. However only a few were observed, reflecting that the area had been cleaned recently.

Project personnel are not aware of any new procedures since the pre BMP monitoring. This is a very large and relatively clean facility, with a significant pellet loss problem during rain events (all catch inserts are pulled to prevent flooding). Project personnel observed the use of manual and driven vacuum sweepers.

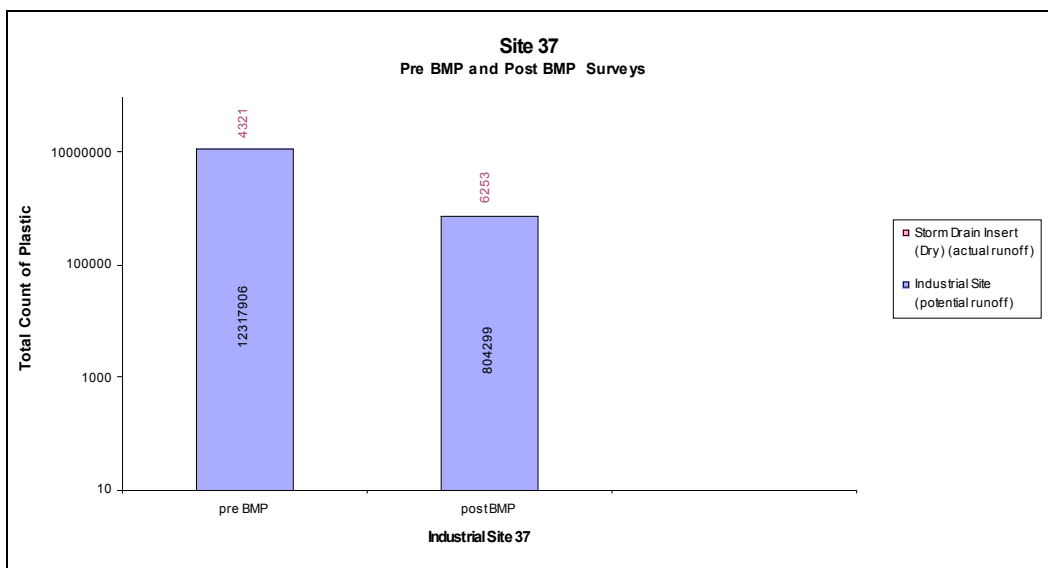
Site 37

The areas outside the facility which project personnel were able to access for sampling purposes were:

1. The public sidewalk on two of the four sides of the facility.
2. The rail yard area behind the facility.
3. The public street and gutter.
4. The catch basin near the rail yard.

This facility has improved, although it was not formally part of the BMP Evaluation sites. We did not sample on their facility, but company personnel observed that the storm drain insert and surrounding areas were being monitored. They made an effort to clean the rail tracks behind their facility, especially nearest the street. There continues to be some pellet loss on the sidewalk and in the gutter leading to the storm drain.

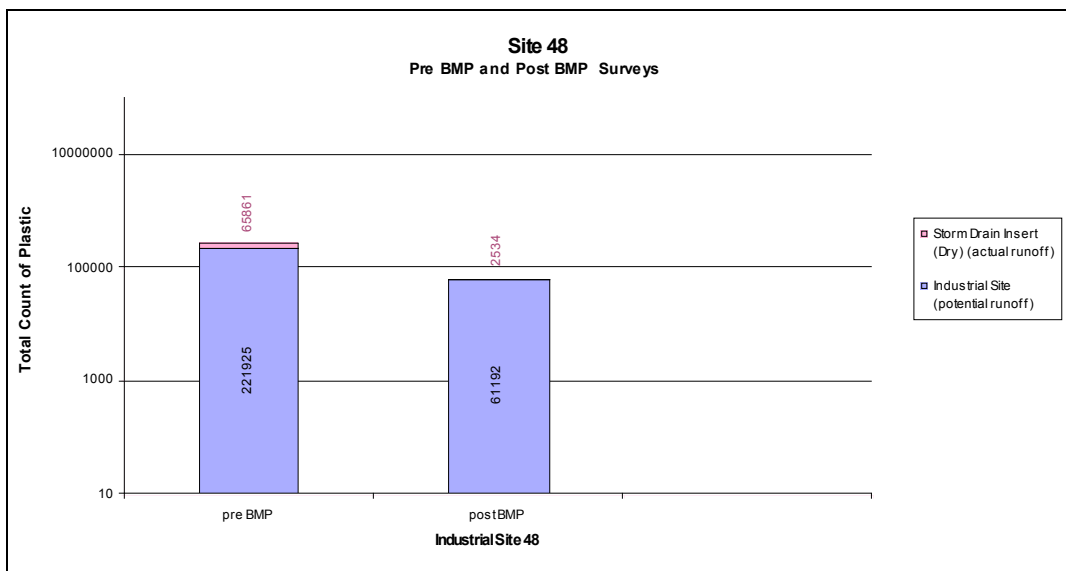
Site 48

The project had inserts put into both catch basins. Pellets could reach them from the following locations:

1. The front parking, loading dock area and the side of the neighboring building.
2. The waste bin area.
3. The driveway to the rear of the building.
4. The rear receiving dock area.
5. The bag house for the cutting operation.

By comparing the pre BMP and the post BMP surveys, this facility has improved.

This is the only company that has taken our advice to purchase a shop vac. It is used with a long extension cord to clean inside and outside. Deployment is based on visual assessment of need and there is no regular schedule for vacuuming. Each employee is trained to clean up spills at meetings to discuss pellet loss recommended by the project. They reported having had such meetings at the time of post BMP monitoring. They put up the OCS posters with clear acrylic sheet covers in prominent places in the warehouse front and back.

They have informed the dispatcher of delivery trucks that the truck drivers must inform warehouse employees if they are dirty and they will clean them out before they leave. No sweeping out of unloaded trucks is allowed in the parking lot.

They have looked for someone to recycle the relatively small amount of mixed pellets that they have, but have not found anyone. Trash pellets were bagged and put in the dumpster.

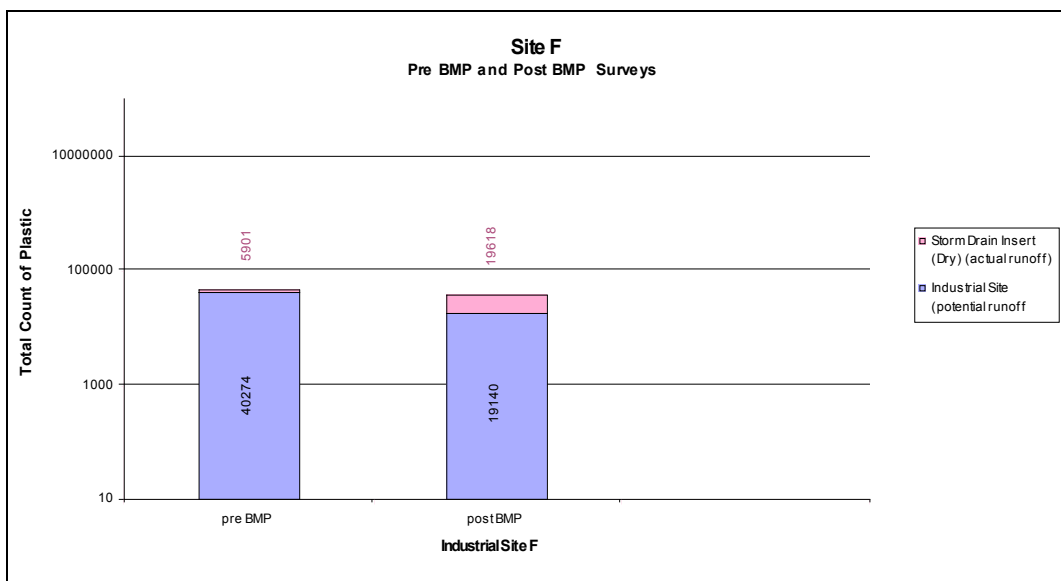
Site F

Pellets could reach the catch basin from the following areas:

1. The rear silo area.
2. The delivery/storage area.
3. The sidewalk.
4. The dumpster area.
5. The gutter on the street in front of the company.

By comparing the pre BMP and the post BMP surveys, this facility has improved in pellets on the ground subject to runoff, but actual pellets in the catch basin inserts have gone up.

No suggestions for BMPs were adopted. Management stated that they sweep up and recycle pellets every other day based on visual inspection at the beginning of the shift. They have one cleanup person, but others can help. Owner said he saw a delivery company sweeping pellets back into the delivery truck.

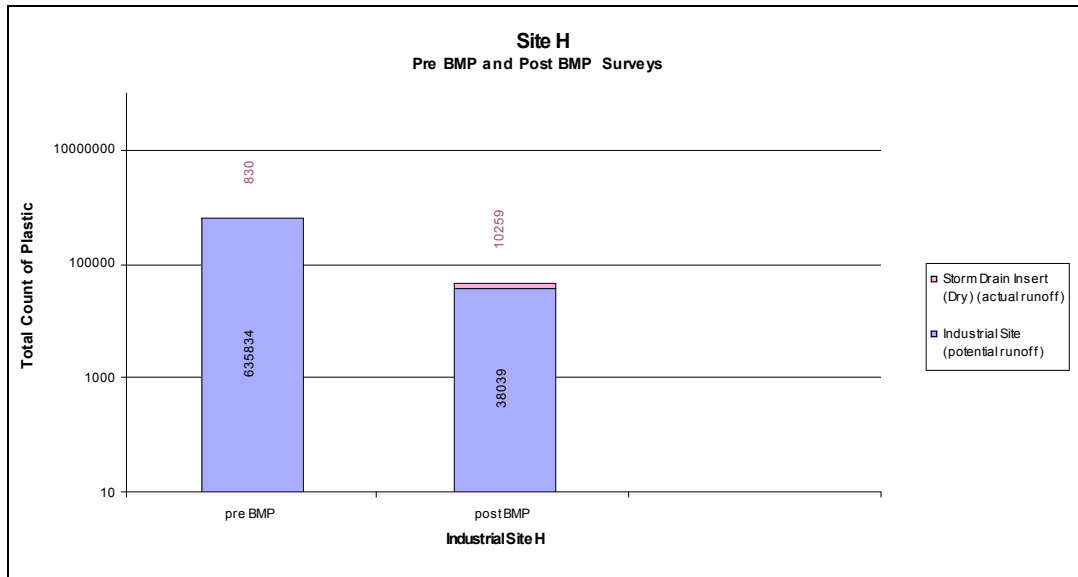
Site H

Areas where pellets and dusts could enter the storm drain system are:

1. The pipe storage area on the side of the building.
2. The parking lot.
3. The sidewalk and gutter on the street.

This facility has improved, although it was not formally part of the BMP Evaluation sites. They did allow us to sample front of the facility during the pre BMP monitoring and allowed us to come back for the post BMP monitoring to do the same area. They continue to have spills of

plastic fragments (regrind) and pellets in the driveway, and at the side of the driveway. There was considerably more plastic present in the post BMP catch basin samples.

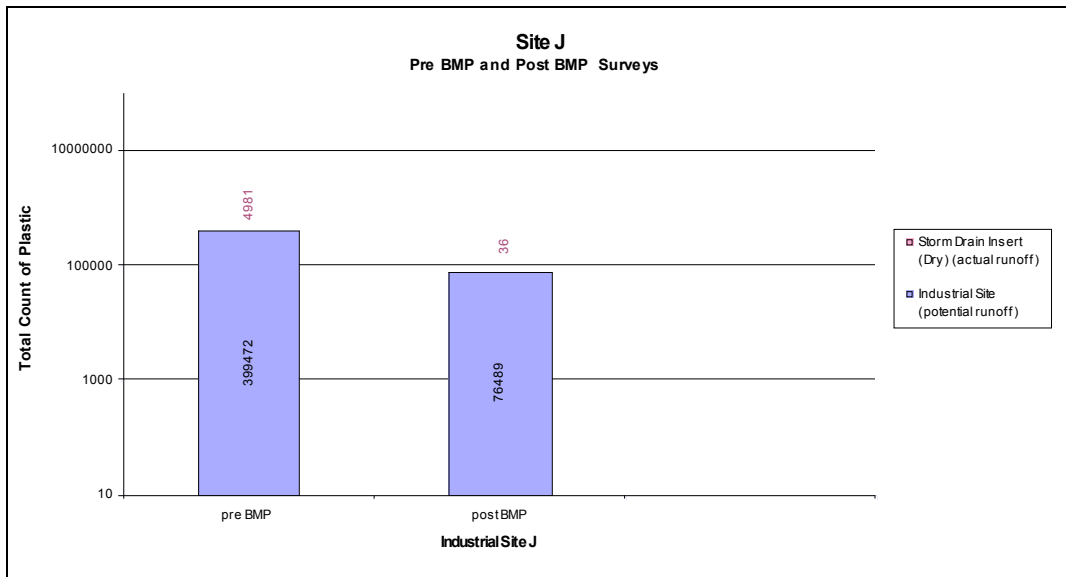
Site J

Outside areas where pellets and powders were observed include:

1. Street level loading and unloading areas.
2. Box and bag handling areas.
3. Regrind/recycling areas.
4. Warehouse storage area.
5. Waste disposal dumpster area.

By comparing the pre BMP and the post BMP surveys, this facility has improved.

New BMP measures reported by the management are being established all the time. They have established cleanup stations and each employee does their cleanup. The manager also said they had had a training session. They have put plastic bags inside their Gaylord containers that they use for Roto Mold Scrap to prevent sawdust from escaping. However some sawdust had escaped and was on a pallet. There was plastic debris observed on both sides of the street though in a lesser degree. Plastic shavings were observed on the sidewalk and in the tree wells. Spills of plastic feedstock powders (blue, red and green) were visible in the parking lot. And plastic dust was visible on the vertical face of the curb on the public street.

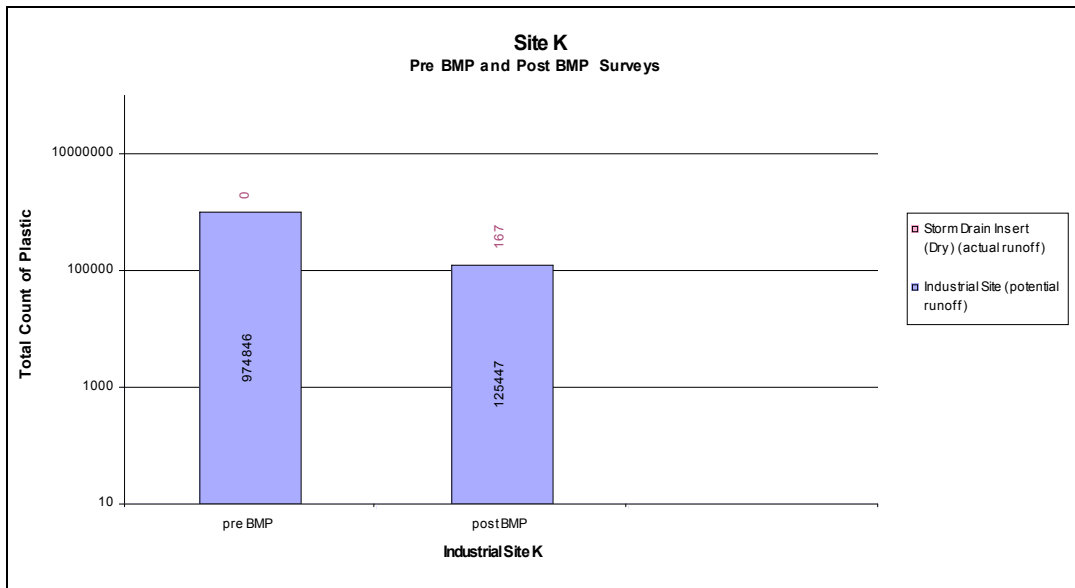
Site K

Areas where pellets and powders could wash to the sump are:

1. The parking lot and dumpster area.
2. The truck delivery and loading area.
3. The rail yard which is partially paved.
4. The area behind the facility where powders are filtered out of the pellet delivery system.

By comparing the pre BMP and the post BMP surveys, this facility has improved.

New BMP measures were observed at the back of the facility in the dust collection system, which now has a sock taped around the automatically opening valve which blows out dust, so the amount that reaches the ground is reduced. A way in which pellet loss is worse is that there were no pans under the railcar valves, and the spills on the ground by the railcars were not contained. Pellets were in evidence in the ditch leading to the storm drain by the rail car. The dumpsters had only a small amount of pellets around them, and the dumpsters were covered.
