MEASURING THE EFFECTIVENESS OF VOLUNTARY PLASTIC INDUSTRY EFFORTS: AMRF'S ANALYSIS OF OPERATION CLEAN SWEEP

C.J. Moore, G.L. Lattin, A.F. Zellers

Algalita Marine Research Foundation, 148 N. Marina Drive, Long Beach, CA 90803, USA

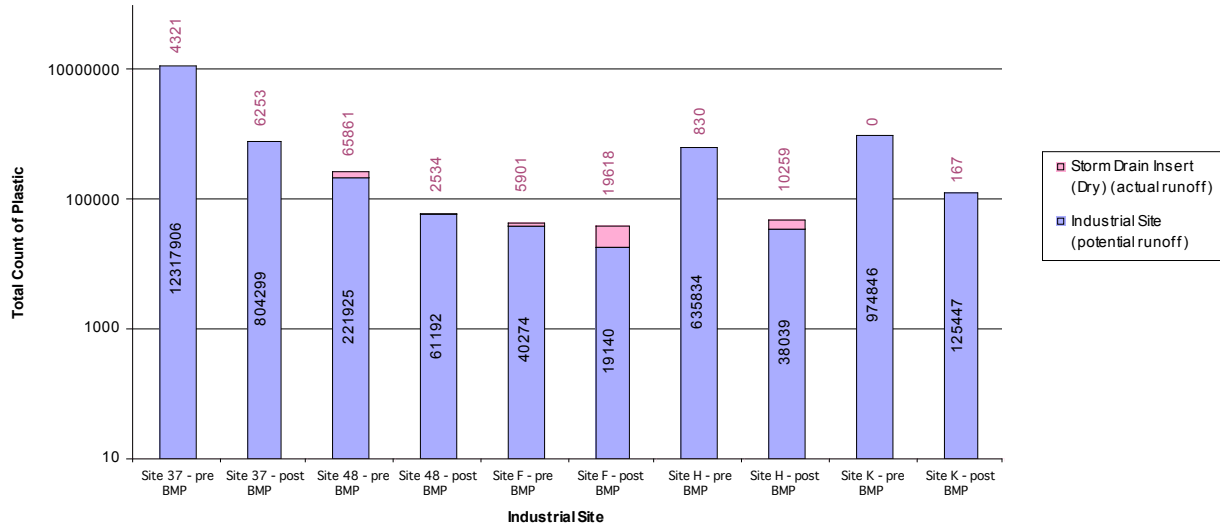
Los Angeles River Watershed
Pre BMP and Post BMP Industrial Site Surveys

The project found plastic pellets and particles in and on rail yard gravel, combined with on site spills, to harbor 42.7 million plastic particles greater than 1mm in size capable of running off into the storm drain system prior to BMP implementation. The count after BMP implementation was 10.5 million. Particles that would have entered the storm drain system during dry weather had the project not installed catch basin inserts near the facilities pre-BMP totaled 0.2 million and 0.09 million post-BMP. These particles were taken directly from the inserts.
